2023:10

# Whole Life Carbon Impact of: **45 Timber Buildings**

Camilla Ernst Andersen, Agnes Garnow, Christian Grau Sørensen, Alexandra Wittchen,  
Liv Kristensen Stranddorf, Endrit Hoxha, Freja Nygaard Rasmussen, Harpa Birgisdottir

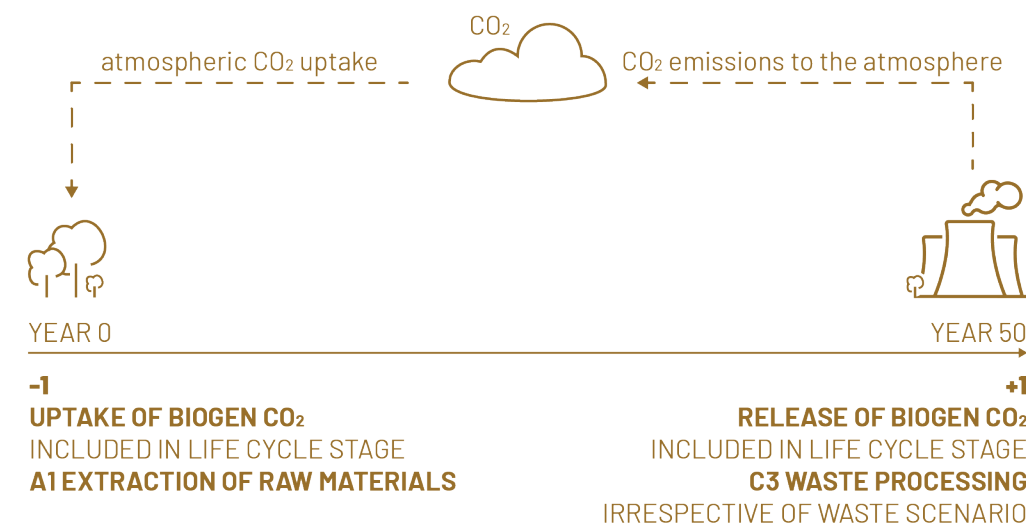
**Figure 2. Method for calculating biogenic CO<sub>2</sub> in bio-based products**

Potential environmental impact of timber products is calculated using the -1/+1 method, which assumes that biogenic carbon is captured and stored by trees (+1) used in construction. It is emitted later at the end-of-life stage (-1).

The European standard EN 15804 (CEN, 2013) stipulates that biomass carbon capture is characterised as -1 kg CO<sub>2</sub> eq per kg CO<sub>2</sub> captured from the atmosphere. This is part of the Product stage (module A1) and a negative impact is therefore obtained at the Product stage when using wood. The negative impact in the Product stage is, in turn, offset at the End-of-Life stage (module C3), irrespective of disposal method. Here it is characterised as the corresponding amount of CO<sub>2</sub> in the biomass, so +1 kg CO<sub>2</sub> eq per kg CO<sub>2</sub>. In the overall life cycle, therefore, wood will emerge as carbon neutral for the stored carbon in the biomass (CEN, 2014). Fossil emissions from the production of wood will continue to vary depending on the different life-cycle stages, as they are linked to the production methods used for the specific products. This calculation method is typically referred to as the -1/+1 method, illustrated in Figure 2. In 2020, the new European standard EN15804:2012+A2:2019 came into force (CEN, 2019). This includes several amendments relative to calculating environmental impact for wood products, however, the -1/+1 method is still in use (CEN, 2019). The standard aims to increase the transparency of the CO<sub>2</sub> capture and emission by trees by stipulating that fossil and biogenic emissions are declared separately.

It is important to note that the -1/+1 method does not take future disposal scenarios into account. This means that regardless of whether the wood is burnt, recycled, or reused, the biogenic CO<sub>2</sub> is calculated as emissions at the end-of-life stage. Differences in environmental impact between disposal scenarios will therefore only occur due to fossil emissions associated with a specific disposal scenario. This ensures that the biogenic CO<sub>2</sub> ranks as neutral within each life cycle, avoiding double counts.

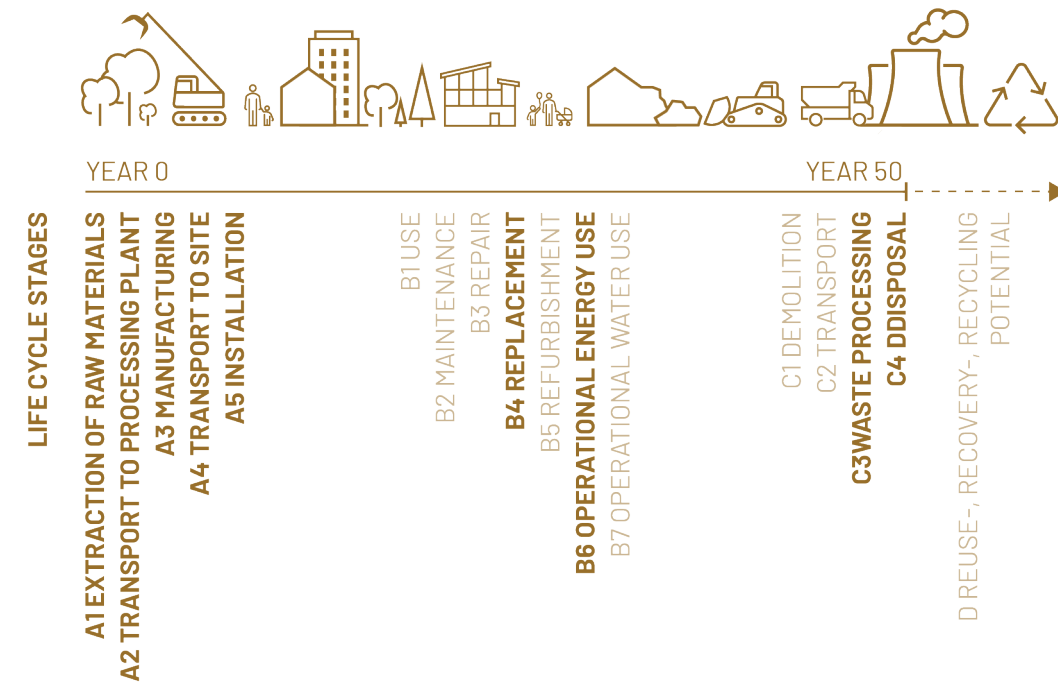
**Figure 5. Life cycle stages included in the building case studies**

The overall life cycle stages of buildings comprise the stages: Product (A1-A3), Construction Process (A4-A5), Use (B1-B7), End of Life (C1-C4), and Beyond Life Cycle (D), of which the marked life-cycle stages are included in the LCAs of building case studies.

This study includes the life-cycle stages of manufacture and transport of building materials (A1-3), transport to building site and construction process (A4-5), replacement of building parts (B4), operational use of energy (B6), and end-of-life waste disposal (C3-4). Figure 5 illustrates all the modules covered by EN 15798 (CEN, 2012) and indicates the modules included in this study (Andersen et al., 2021, p.16).

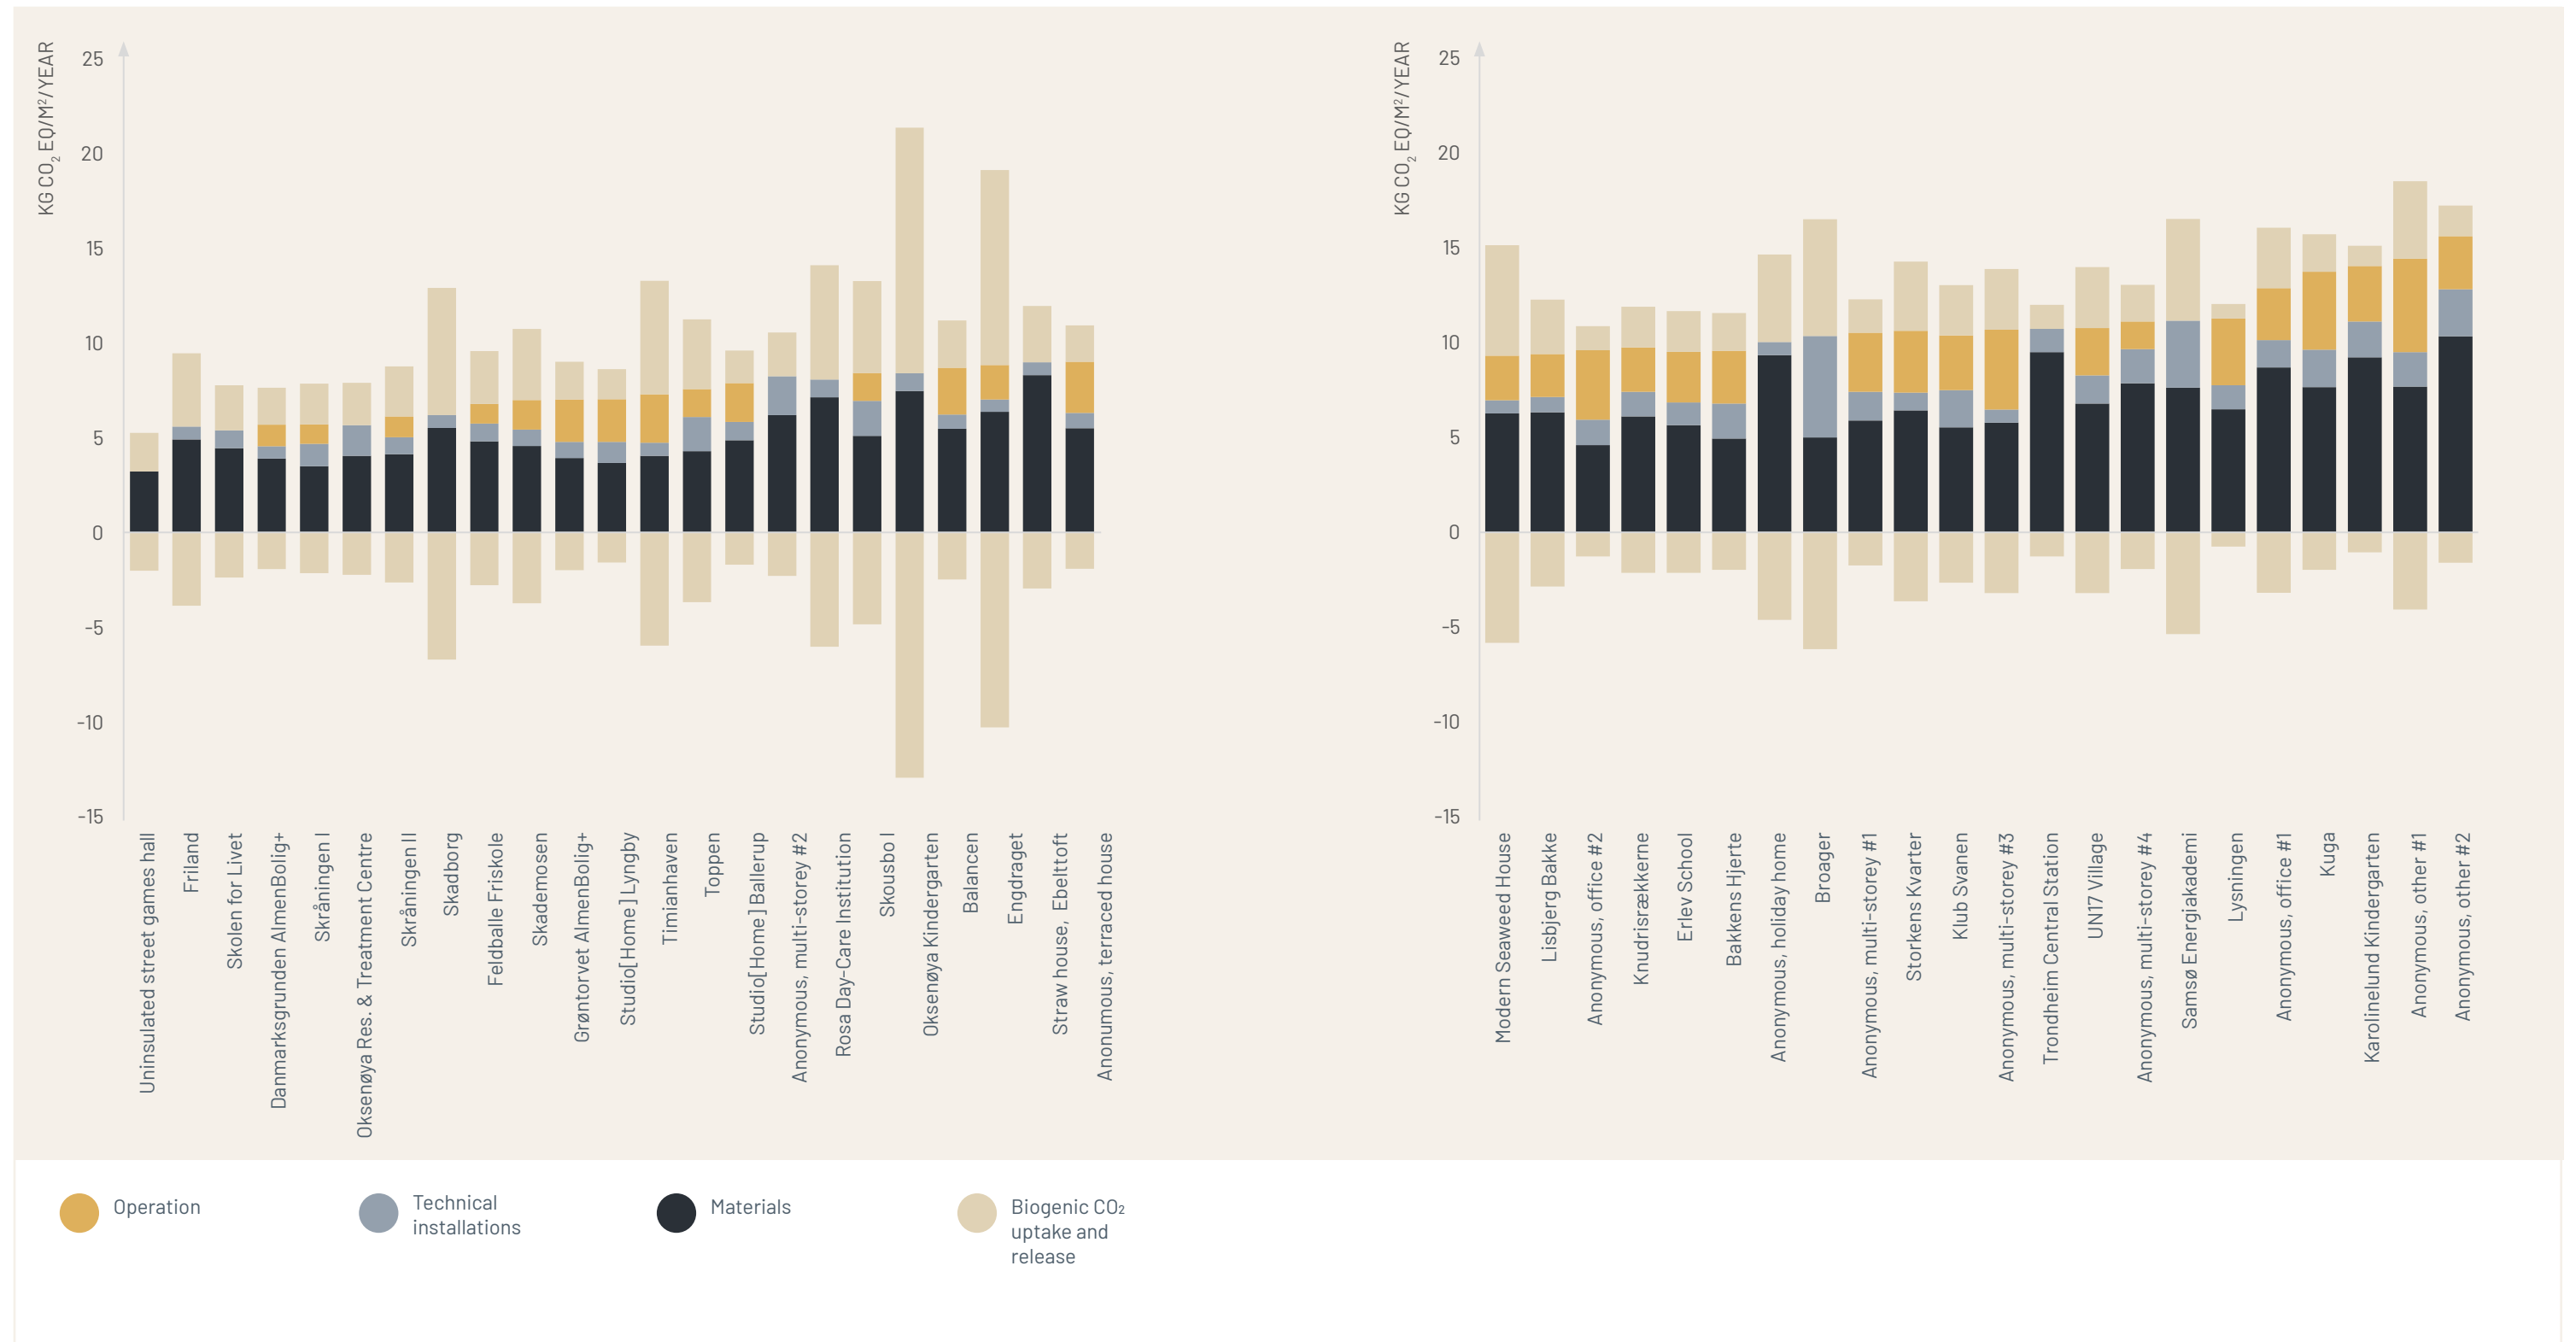
# OPERATION AND MATERIALS

Below, the results of LCAs for all 45 case studies distributed on two graphs. Thus, the guidelines apply to both graphs. The results are specified in kg CO<sub>2</sub> eq/m<sup>2</sup>/year. The results are distributed on impact from materials, technical installations, and usage as well as biogenic CO<sub>2</sub> capture and emission. Please note that the technical installations for drains and water, heating, ventilation, and cooling systems are based on generic values, whereas electricity and mechanical systems are specific values.

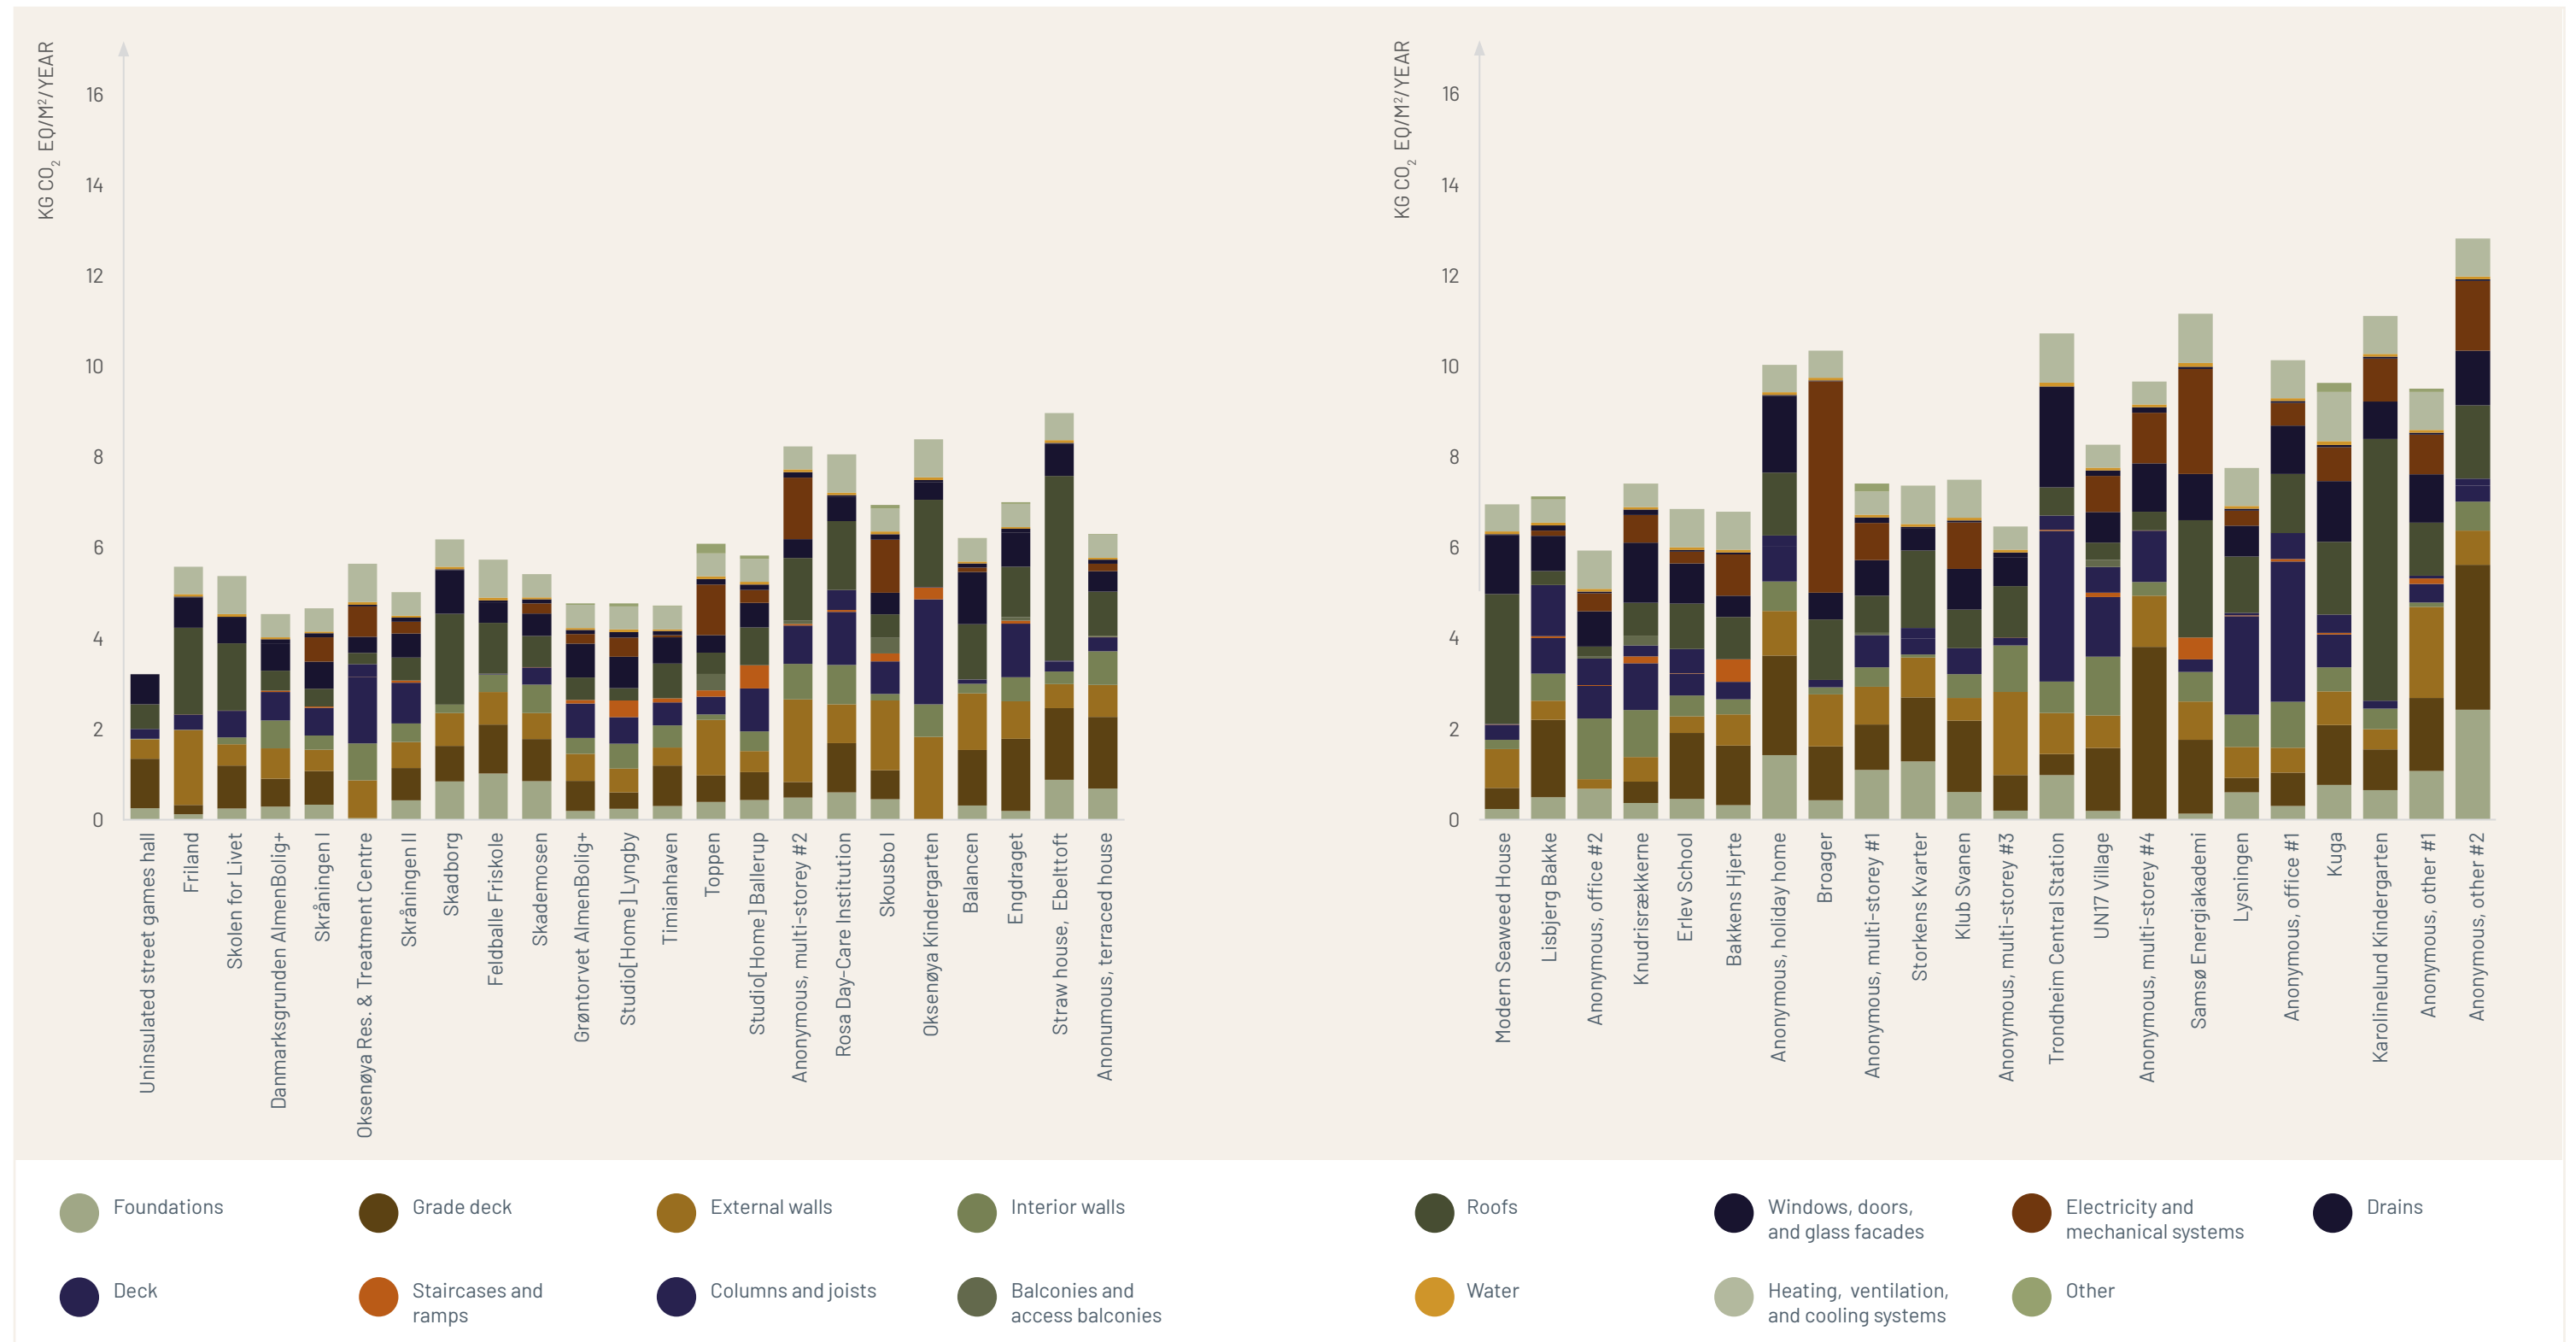
# BUILDING PARTS

Below, the results of LCAs for all 45 case studies distributed on two graphs. Thus, the guidelines apply to both graphs. The results show the environmental impact distributed on building parts and is stated in kg CO<sub>2</sub> eq/m<sup>2</sup>/year. The building parts drains and water, heating, ventilation and cooling systems are based on generic values, whereas electricity and mechanical systems are specific values. Please note that the biogenic CO<sub>2</sub> content is not shown separately.

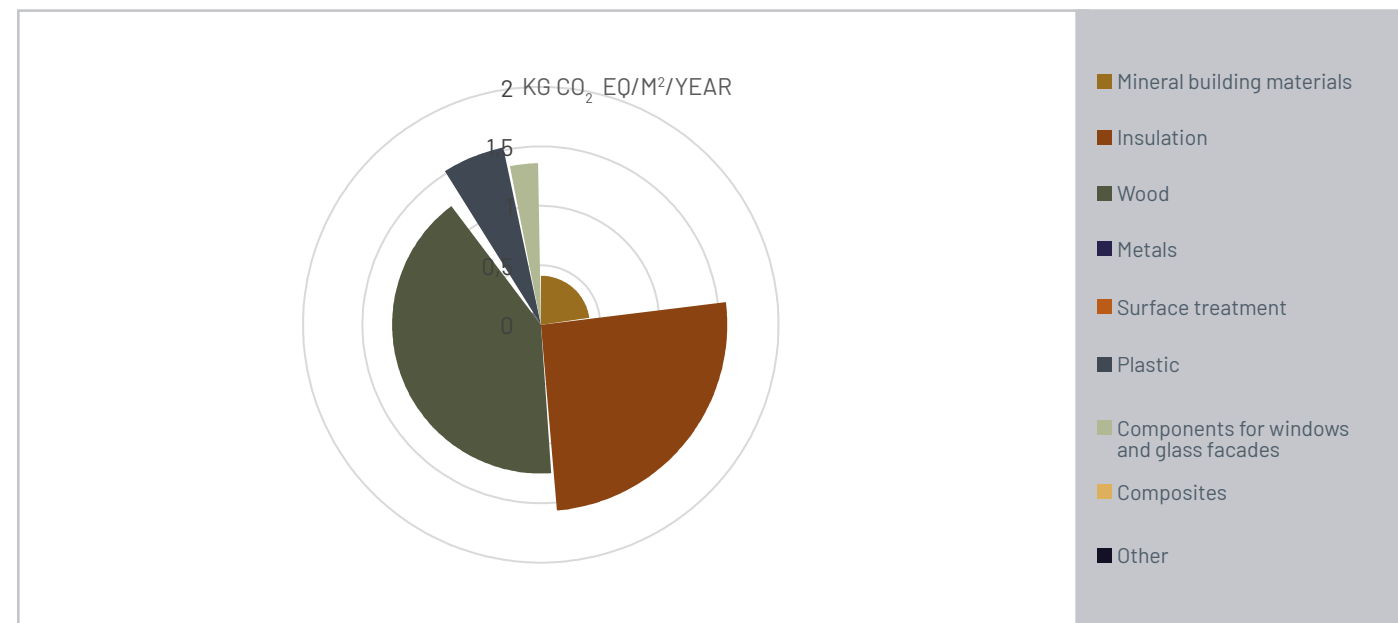
**Figure 2. Material distribution and CO<sub>2</sub> emissions**

The pie chart shows the distribution of materials measured in kg for the mineral building materials group: insulation, wood, metals, surface treatment, plastic, components for windows and glass facades, composites, and other construction-related items (%). The axis shows the emission of greenhouse gases stated in CO<sub>2</sub> eq/m<sup>2</sup>/year distributed on material categories. Please note the scale of the axis varies.

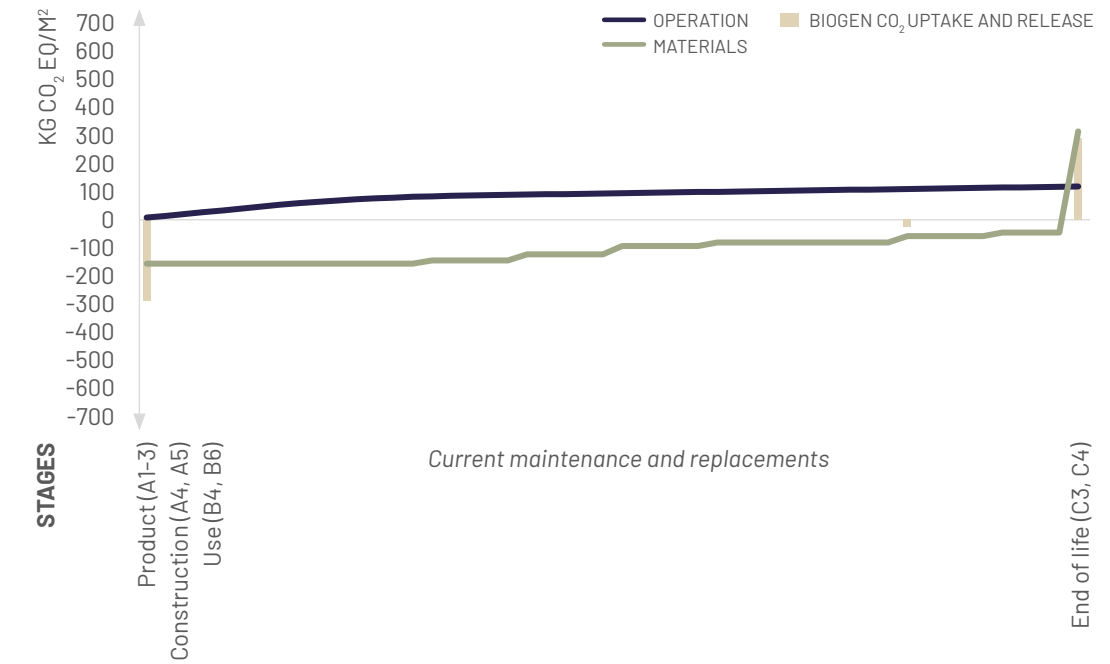
**Figure 3. CO<sub>2</sub> accounting: life-cycle stages**

The horizontal axis shows the distribution of life-cycle stages in the building over a 50-year period. In year 0, there are emissions from the Manufacture and Construction stages (A1-A3 and A4 and A5, respectively). Between years 1-49, there are emissions from the Use stage (B4 and B6). In year 50, there are emissions from the End-of-life stages (C3 and C4). The vertical axis shows the emission of greenhouse gases stated in CO<sub>2</sub> eq/m<sup>2</sup> distributed on materials and use. The biogenic CO<sub>2</sub> content is shown as columns corresponding to the capture and emission of biogenic CO<sub>2</sub> during the reference study period cf. the -1/+1 method.

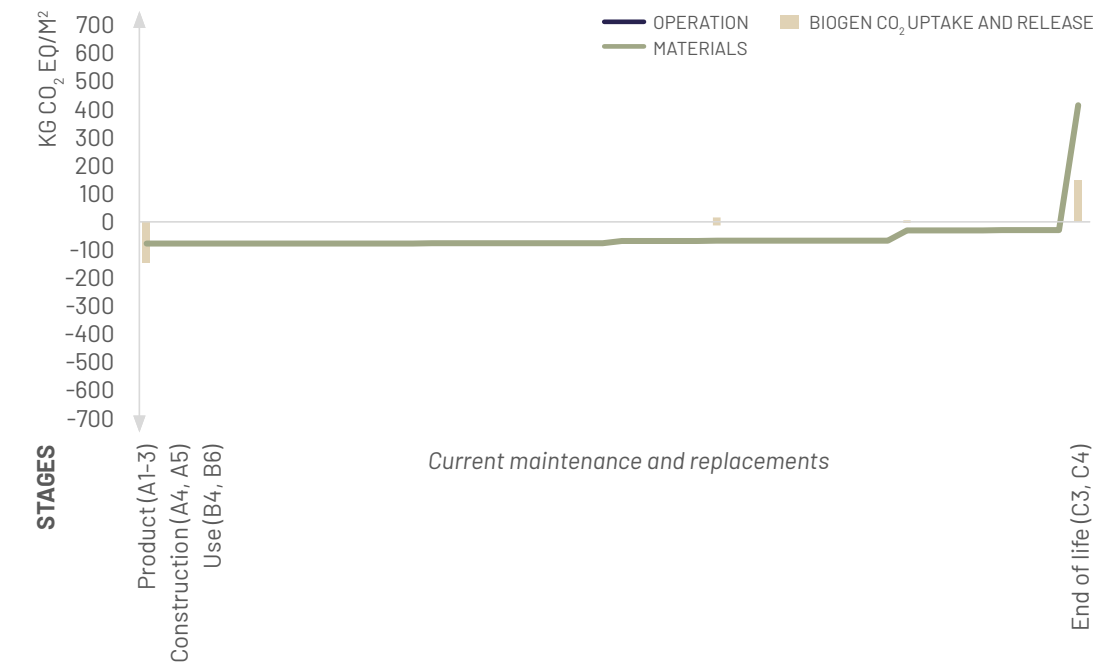
**Figure 3. CO<sub>2</sub> accounting: life-cycle stages**

The horizontal axis shows the distribution of life-cycle stages in the building over a 50-year period. In year 0, there are emissions from the Manufacture and Construction stages (A1-A3 and A4 and A5, respectively). Between years 1-49, there are emissions from the Use stage (B4 and B6). In year 50, there are emissions from the End-of-life stages (C3 and C4). The vertical axis shows the emission of greenhouse gases stated in CO<sub>2</sub> eq/m<sup>2</sup> distributed on materials and use. The biogenic CO<sub>2</sub> content is shown as columns corresponding to the capture and emission of biogenic CO<sub>2</sub> during the reference study period cf. the -1/+1 method.

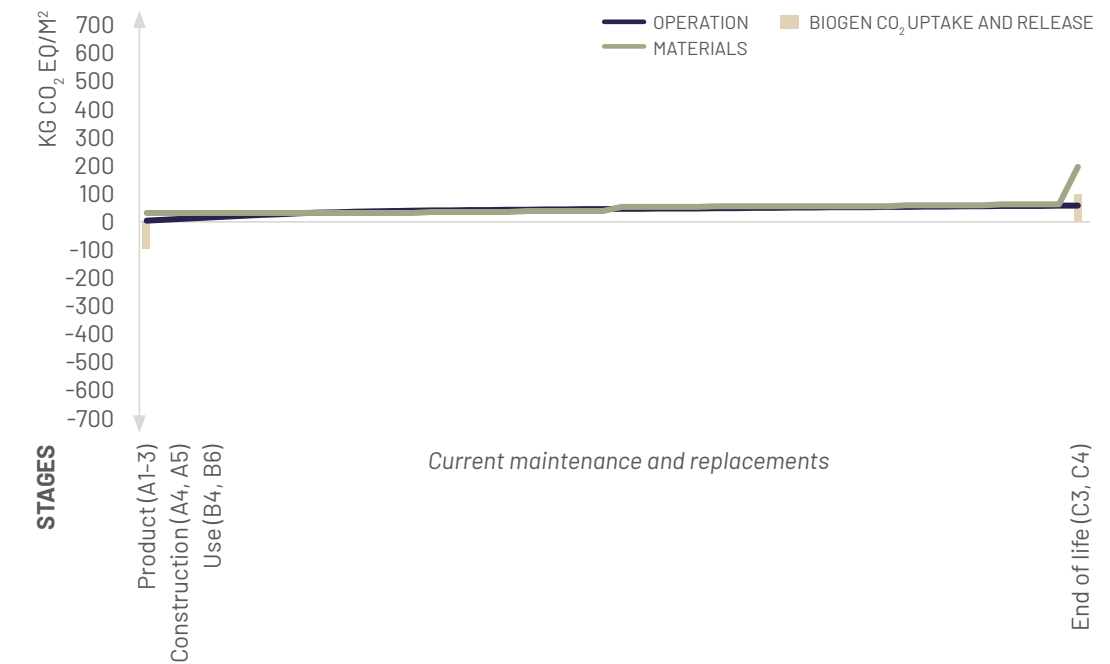
Figure 3. CO<sub>2</sub> accounting: life-cycle stages

The horizontal axis shows the distribution of life-cycle stages in the building over a 50-year period. In year 0, there are emissions from the Manufacture and Construction stages (A1-A3 and A4 and A5, respectively). Between years 1-49, there are emissions from the Use stage (B4 and B6). In year 50, there are emissions from the End-of-life stages (C3 and C4). The vertical axis shows the emission of greenhouse gases stated in CO<sub>2</sub> eq/m<sup>2</sup> distributed on materials and use. The biogenic CO<sub>2</sub> content is shown as columns corresponding to the capture and emission of biogenic CO<sub>2</sub> during the reference study period cf. the -1/+1 method.

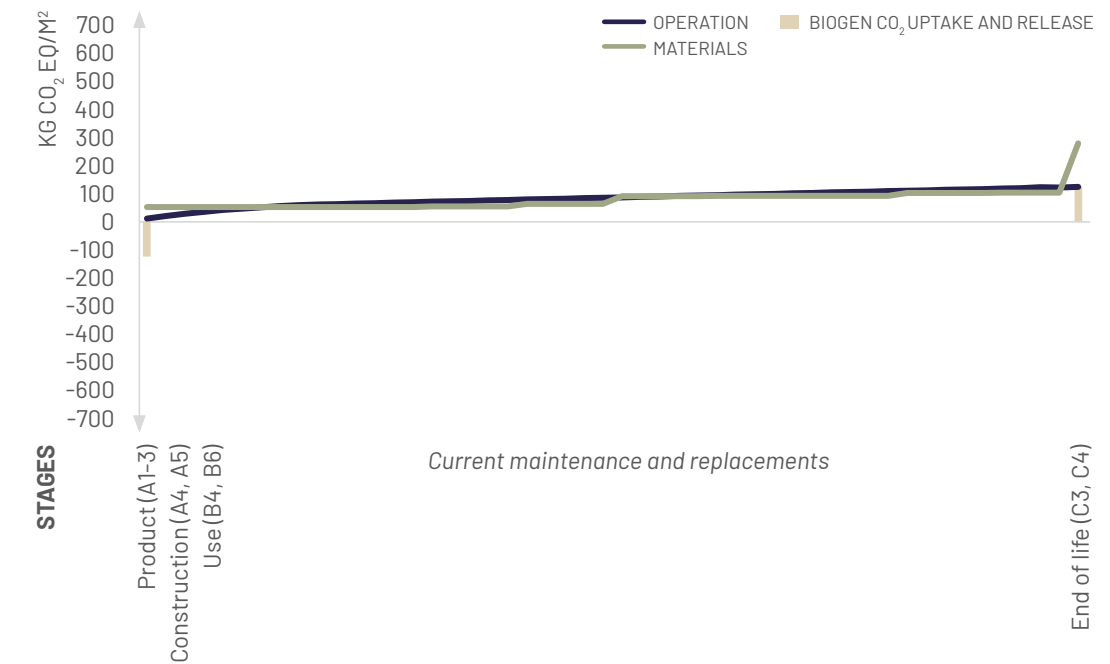
**Figure 3. CO<sub>2</sub> accounting: life-cycle stages**

The horizontal axis shows the distribution of life-cycle stages in the building over a 50-year period. In year 0, there are emissions from the Manufacture and Construction stages (A1-A3 and A4 and A5, respectively). Between years 1-49, there are emissions from the Use stage (B4 and B6). In year 50, there are emissions from the End-of-life stages (C3 and C4). The vertical axis shows the emission of greenhouse gases stated in CO<sub>2</sub> eq/m<sup>2</sup> distributed on materials and use. The biogenic CO<sub>2</sub> content is shown as columns corresponding to the capture and emission of biogenic CO<sub>2</sub> during the reference study period cf. the -1/+1 method.

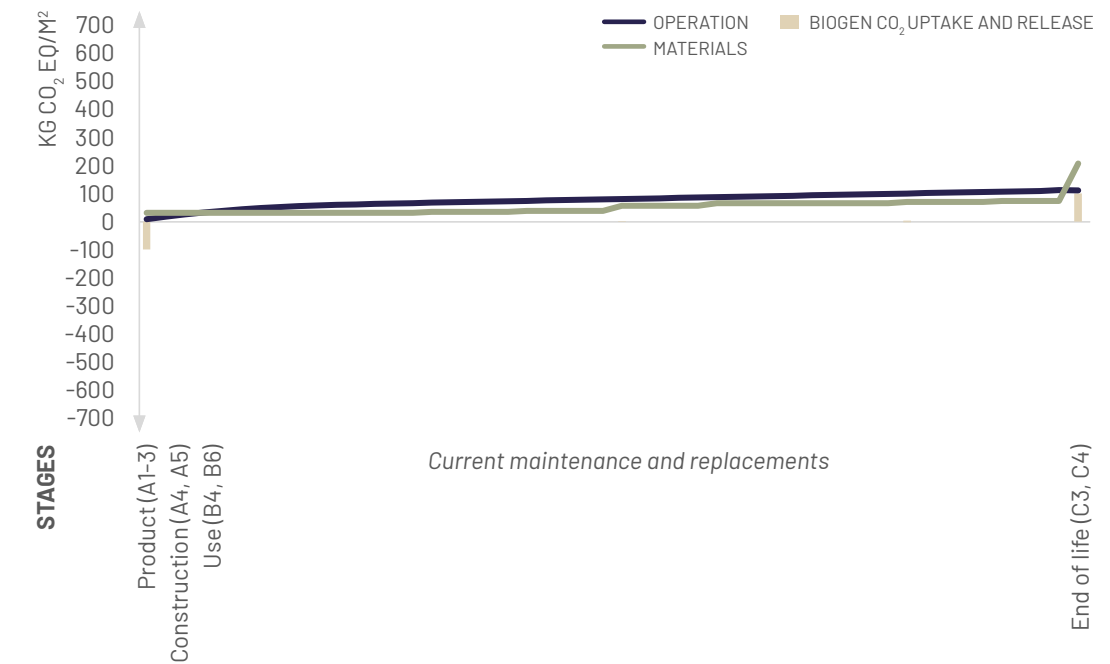
Figure 3. CO2 accounting: life-cycle stages

The horizontal axis shows the distribution of life-cycle stages in the building over a 50-year period. In year 0, there are emissions from the Manufacture and Construction stages (A1-A3 and A4 and A5, respectively). Between years 1-49, there are emissions from the Use stage (B4 and B6). In year 50, there are emissions from the End-of-life stages (C3 and C4). The vertical axis shows the emission of greenhouse gases stated in CO<sub>2</sub> eq/m<sup>2</sup> distributed on materials and use. The biogenic CO<sub>2</sub> content is shown as columns corresponding to the capture and emission of biogenic CO<sub>2</sub> during the reference study period cf. the -1/+1 method.

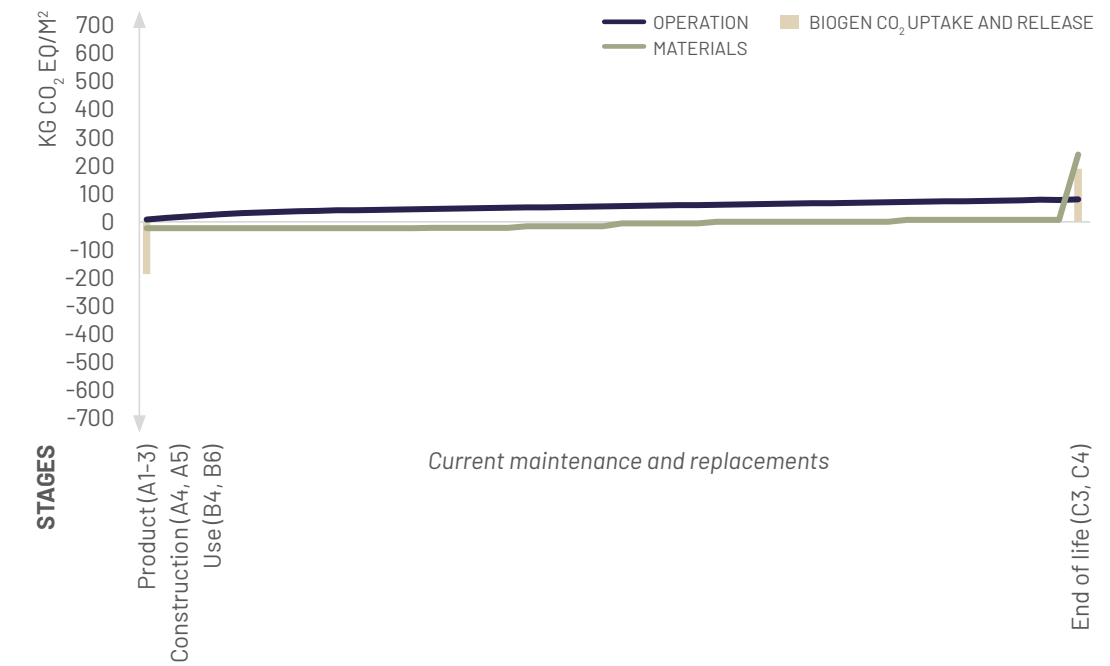
Figure 3. CO<sub>2</sub> accounting: life-cycle stages

The horizontal axis shows the distribution of life-cycle stages in the building over a 50-year period. In year 0, there are emissions from the Manufacture and Construction stages (A1-A3 and A4 and A5, respectively). Between years 1-49, there are emissions from the Use stage (B4 and B6). In year 50, there are emissions from the End-of-life stages (C3 and C4). The vertical axis shows the emission of greenhouse gases stated in CO<sub>2</sub> eq/m<sup>2</sup> distributed on materials and use. The biogenic CO<sub>2</sub> content is shown as columns corresponding to the capture and emission of biogenic CO<sub>2</sub> during the reference study period cf. the -1/+1 method.

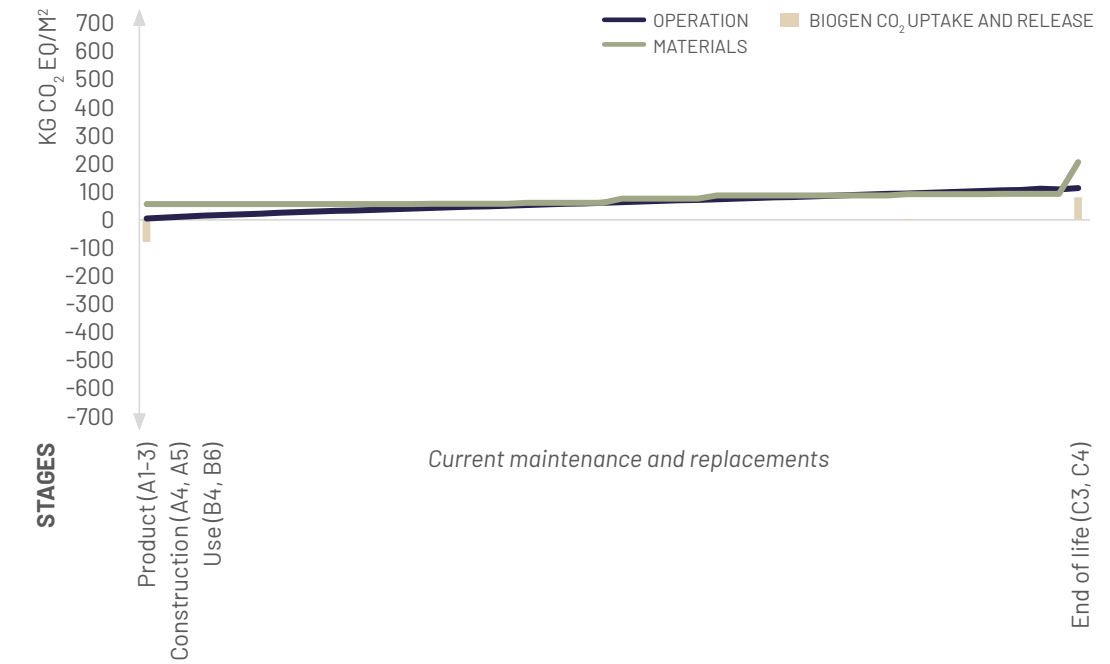
Figure 3. CO<sub>2</sub> accounting: life-cycle stages

The horizontal axis shows the distribution of life-cycle stages in the building over a 50-year period. In year 0, there are emissions from the Manufacture and Construction stages (A1-A3 and A4 and A5, respectively). Between years 1-49, there are emissions from the Use stage (B4 and B6). In year 50, there are emissions from the End-of-life stages (C3 and C4). The vertical axis shows the emission of greenhouse gases stated in CO<sub>2</sub> eq/m<sup>2</sup> distributed on materials and use. The biogenic CO<sub>2</sub> content is shown as columns corresponding to the capture and emission of biogenic CO<sub>2</sub> during the reference study period cf. the -1/+1 method.

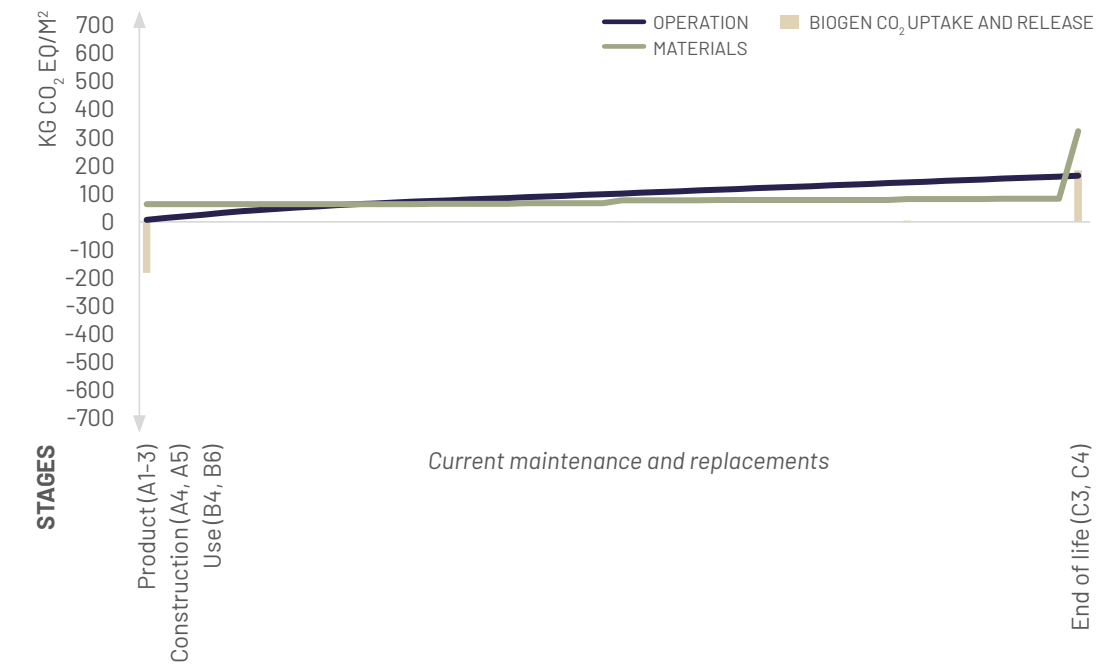
**Figure 3. CO<sub>2</sub> accounting: life-cycle stages**

The horizontal axis shows the distribution of life-cycle stages in the building over a 50-year period. In year 0, there are emissions from the Manufacture and Construction stages (A1-A3 and A4 and A5, respectively). Between years 1-49, there are emissions from the Use stage (B4 and B6). In year 50, there are emissions from the End-of-life stages (C3 and C4). The vertical axis shows the emission of greenhouse gases stated in CO<sub>2</sub> eq/m<sup>2</sup> distributed on materials and use. The biogenic CO<sub>2</sub> content is shown as columns corresponding to the capture and emission of biogenic CO<sub>2</sub> during the reference study period cf. the -1/+1 method.

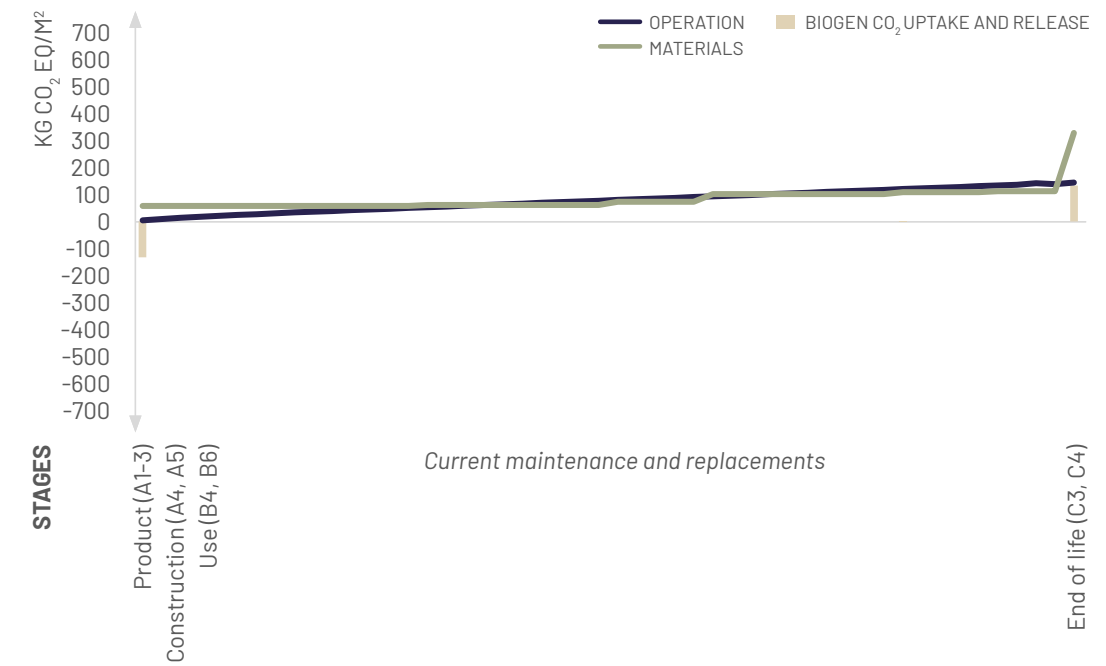
Figure 3. CO<sub>2</sub> accounting: life-cycle stages

The horizontal axis shows the distribution of life-cycle stages in the building over a 50-year period. In year 0, there are emissions from the Manufacture and Construction stages (A1-A3 and A4 and A5, respectively). Between years 1-49, there are emissions from the Use stage (B4 and B6). In year 50, there are emissions from the End-of-life stages (C3 and C4). The vertical axis shows the emission of greenhouse gases stated in CO<sub>2</sub> eq/m<sup>2</sup> distributed on materials and use. The biogenic CO<sub>2</sub> content is shown as columns corresponding to the capture and emission of biogenic CO<sub>2</sub> during the reference study period cf. the -1/+1 method.

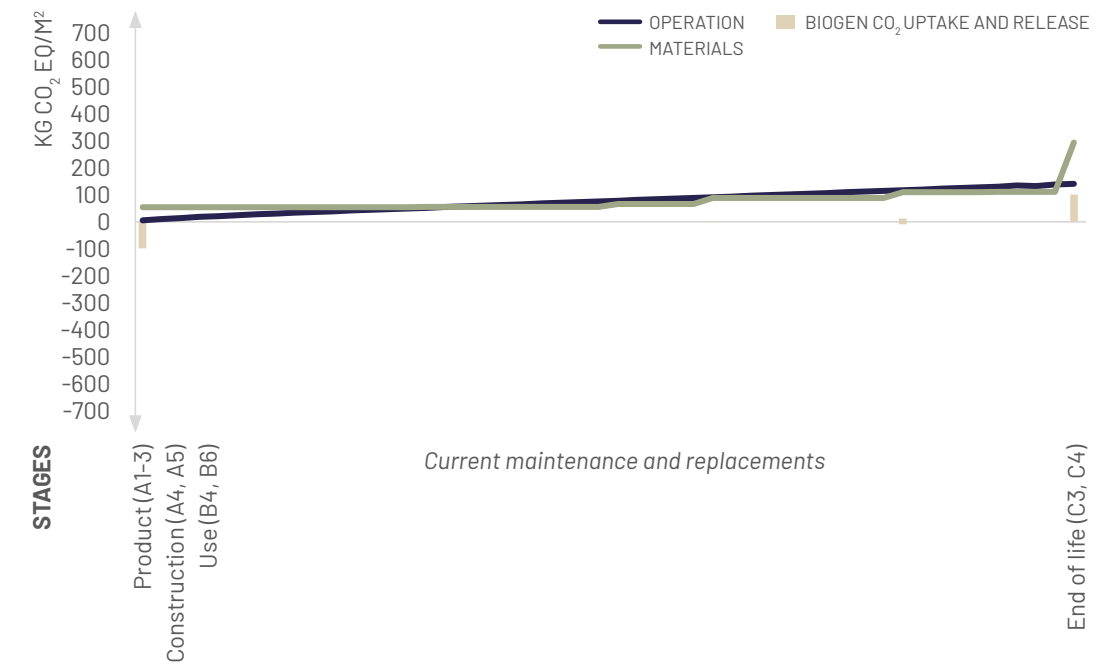
**Figure 3. CO<sub>2</sub> accounting: life-cycle stages**

The horizontal axis shows the distribution of life-cycle stages in the building over a 50-year period. In year 0, there are emissions from the Manufacture and Construction stages (A1-A3 and A4 and A5, respectively). Between years 1-49, there are emissions from the Use stage (B4 and B6). In year 50, there are emissions from the End-of-life stages (C3 and C4). The vertical axis shows the emission of greenhouse gases stated in CO<sub>2</sub> eq/m<sup>2</sup> distributed on materials and use. The biogenic CO<sub>2</sub> content is shown as columns corresponding to the capture and emission of biogenic CO<sub>2</sub> during the reference study period cf. the -1/+1 method.

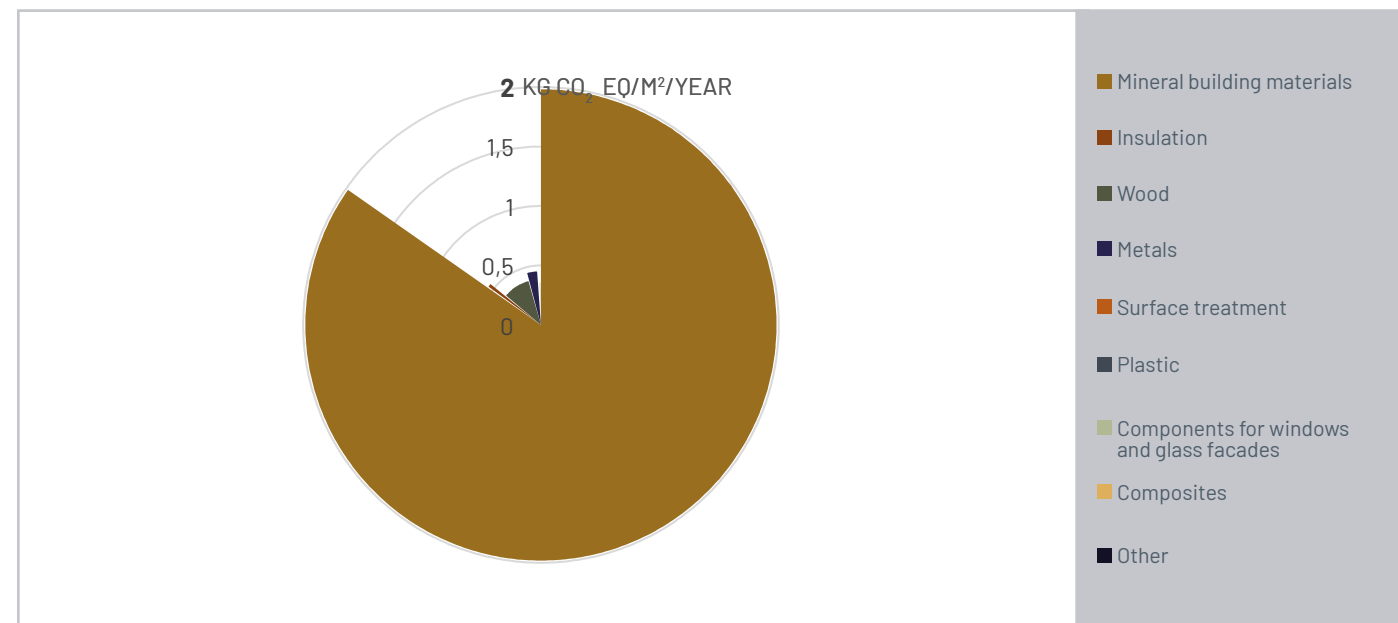
**Figure 2. Material distribution and CO<sub>2</sub> emissions**

The pie chart shows the distribution of materials measured in kg for the mineral building materials group: insulation, wood, metals, surface treatment, plastic, components for windows and glass facades, composites, and other construction-related items (%). The axis shows the emission of greenhouse gases stated in CO<sub>2</sub> eq/m<sup>2</sup>/year distributed on material categories. Please note the scale of the axis varies.

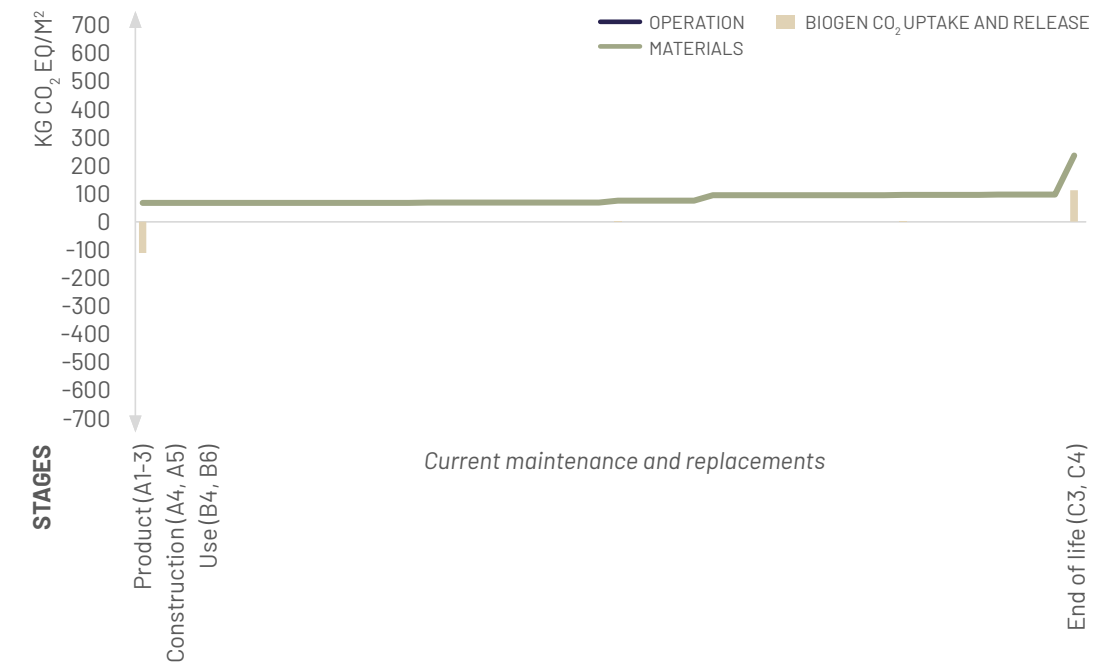
**Figure 3. CO<sub>2</sub> accounting: life-cycle stages**

The horizontal axis shows the distribution of life-cycle stages in the building over a 50-year period. In year 0, there are emissions from the Manufacture and Construction stages (A1-A3 and A4 and A5, respectively). Between years 1-49, there are emissions from the Use stage (B4 and B6). In year 50, there are emissions from the End-of-life stages (C3 and C4). The vertical axis shows the emission of greenhouse gases stated in CO<sub>2</sub> eq/m<sup>2</sup> distributed on materials and use. The biogenic CO<sub>2</sub> content is shown as columns corresponding to the capture and emission of biogenic CO<sub>2</sub> during the reference study period cf. the -1/+1 method.
